A319

***Engine Condition Monitoring
Weekly Report***

ECM-LWA-Y25/W47-MSN2935

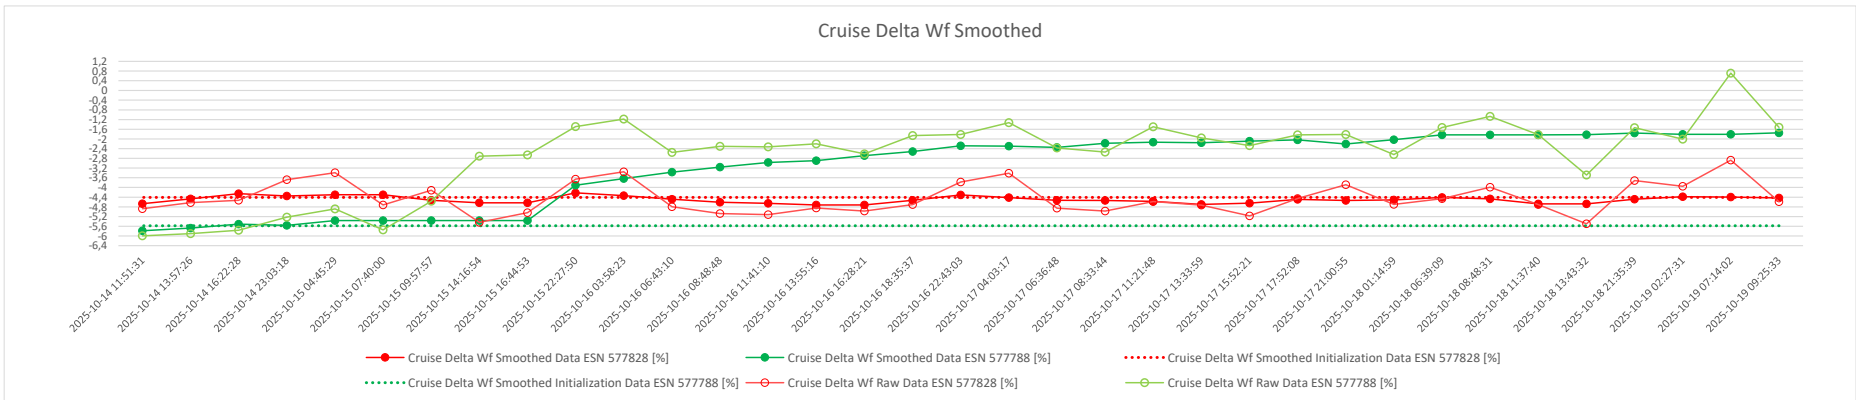
The engine in question experienced erratic shifts and/or lapses (Vibration = 0 Units) in fan/core vibrations at both cruise and takeoff as indicated by the **rear vibration sensor**. All other engine parameters are normal.

ESN 577828 and ESN 577788 have been checked for primary parameters shifts from baselines and for secondary parameters limits as per approved maintenance manuals.
