A319

Engine Condition Monitoring

Weekly Report

ECM-LWA-Y26/W8-MSN2935

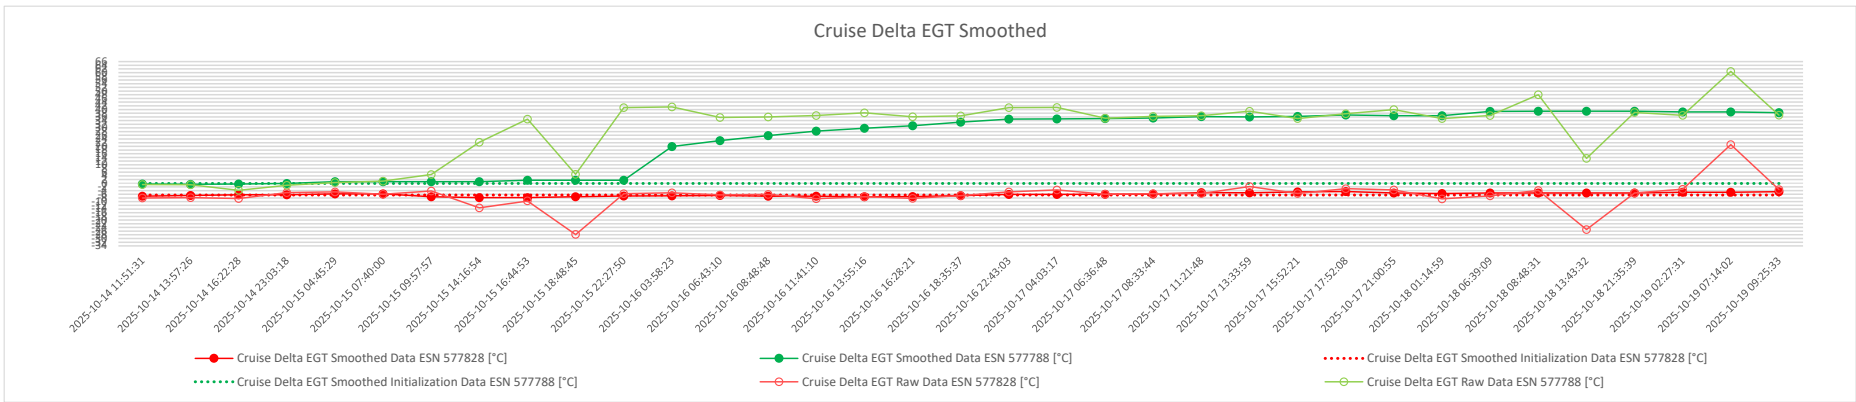
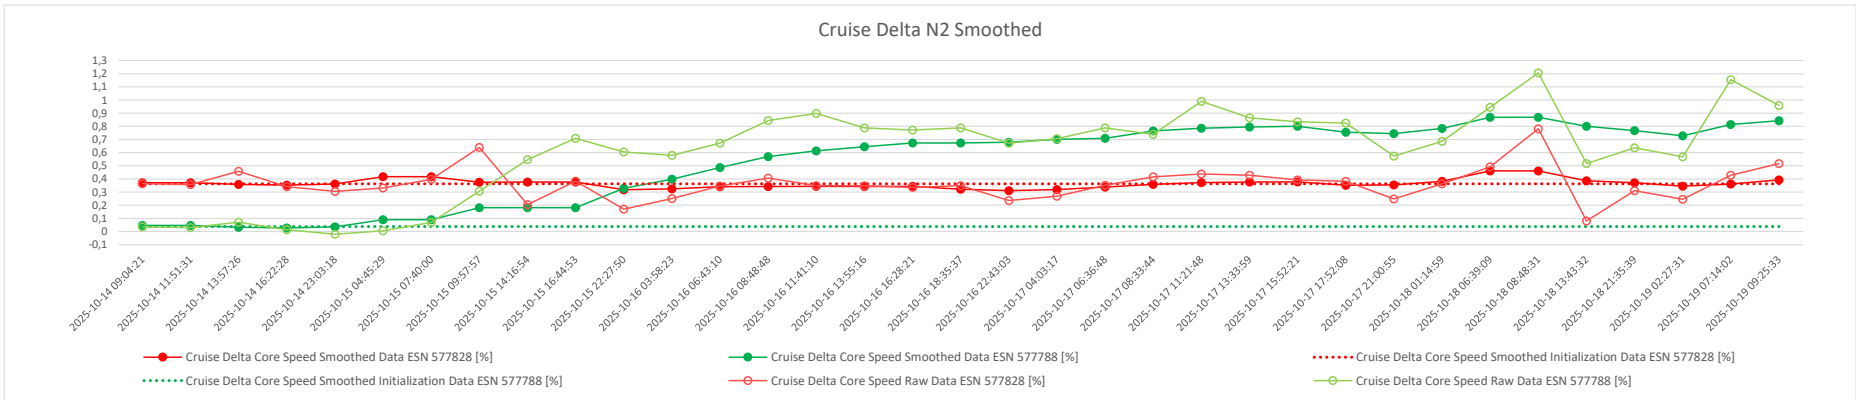
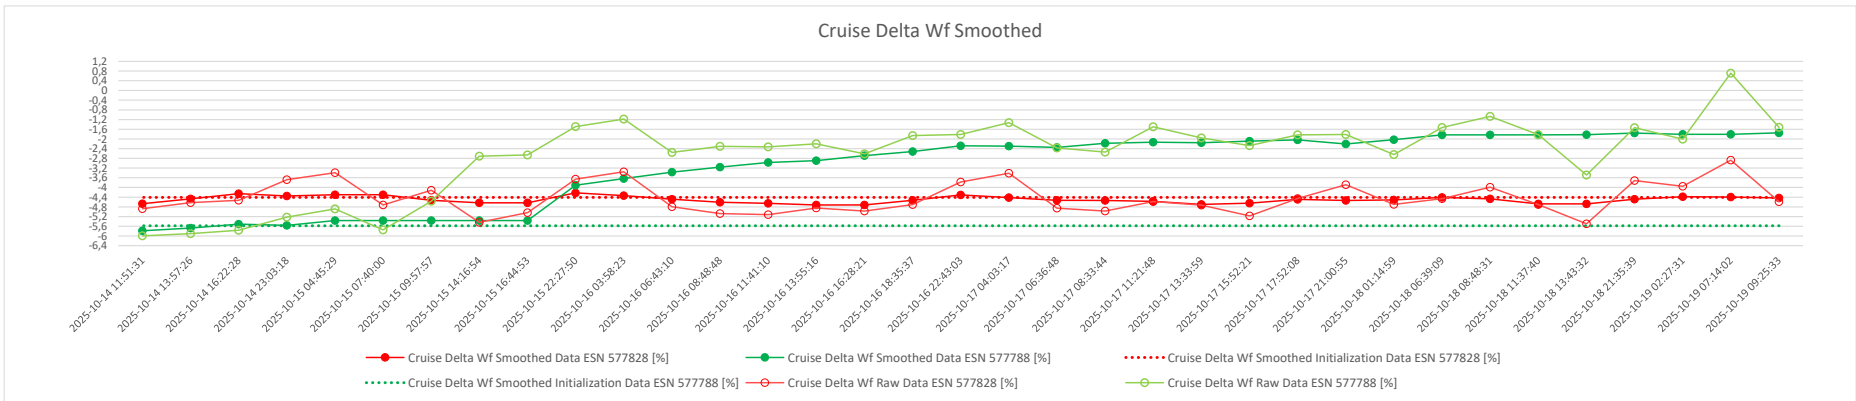
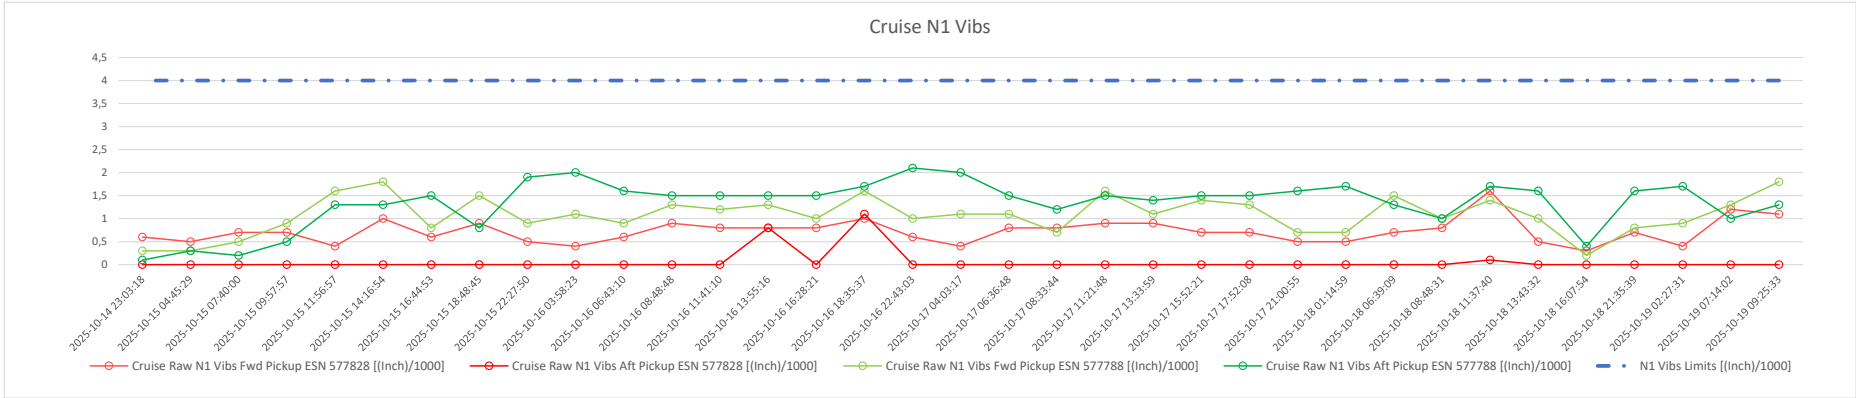
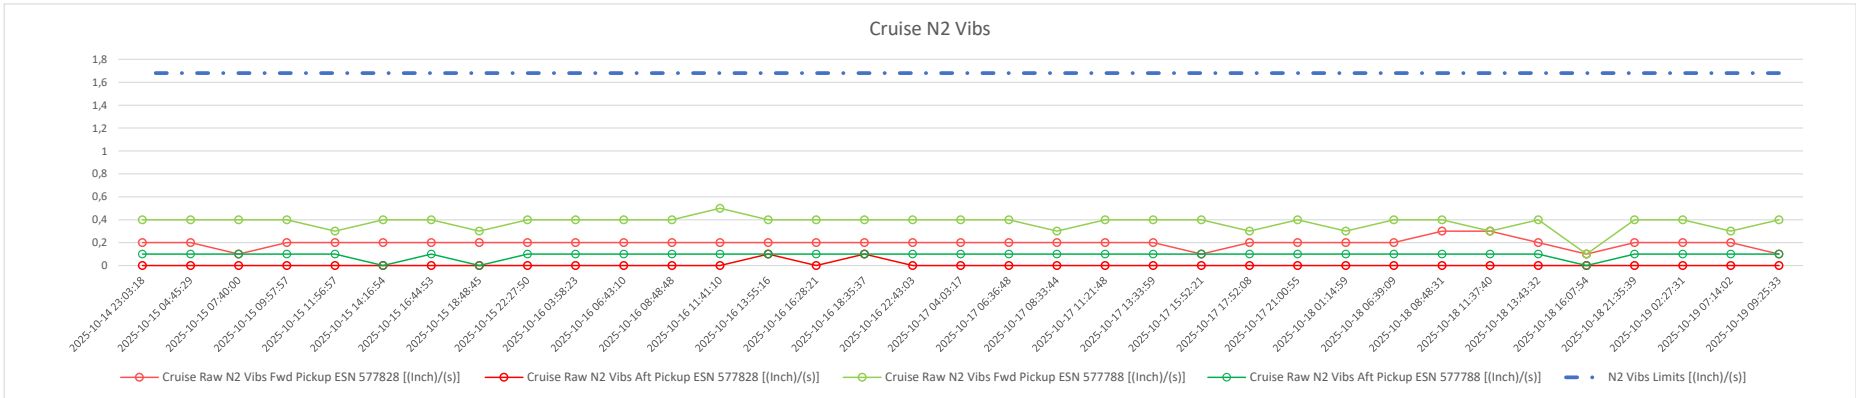
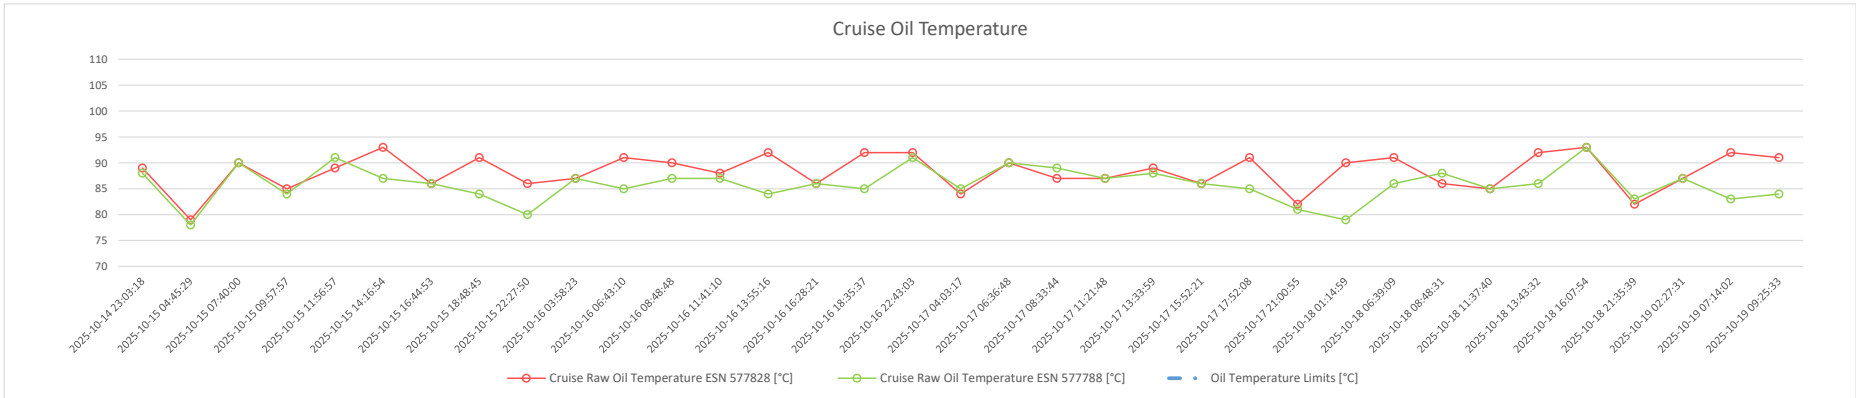
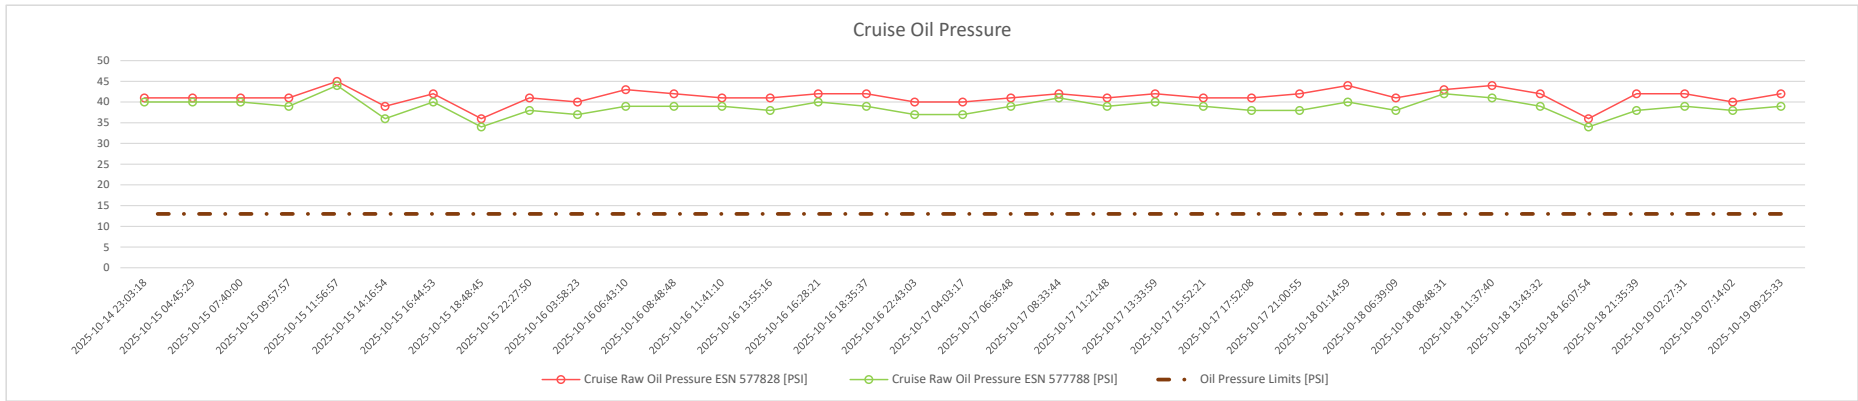
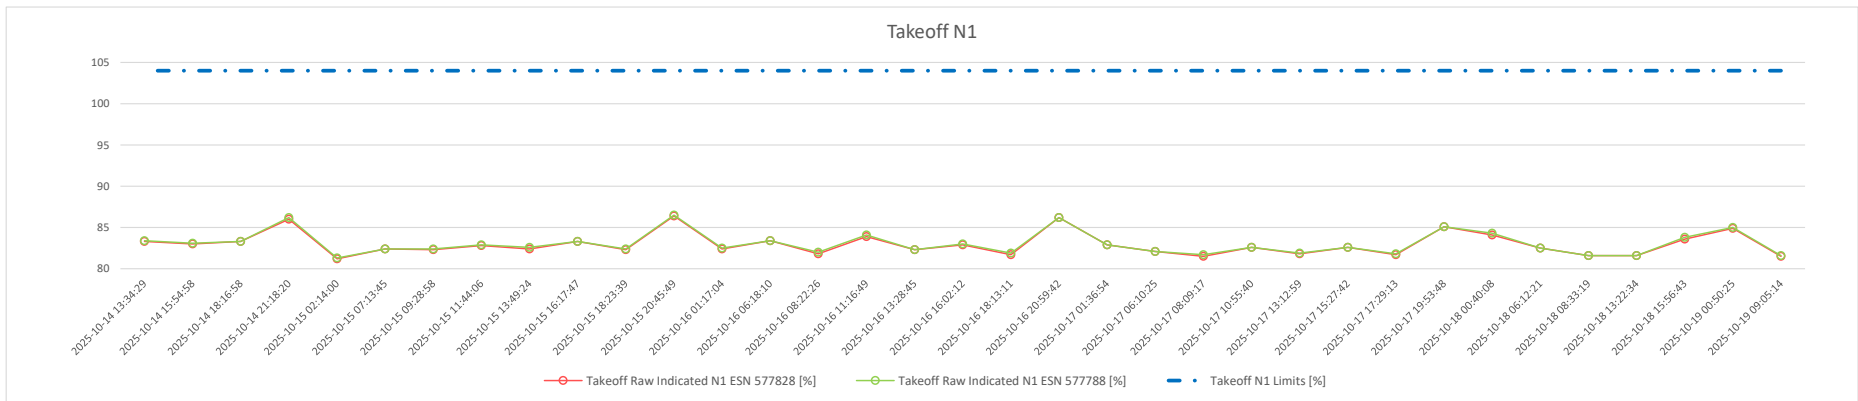
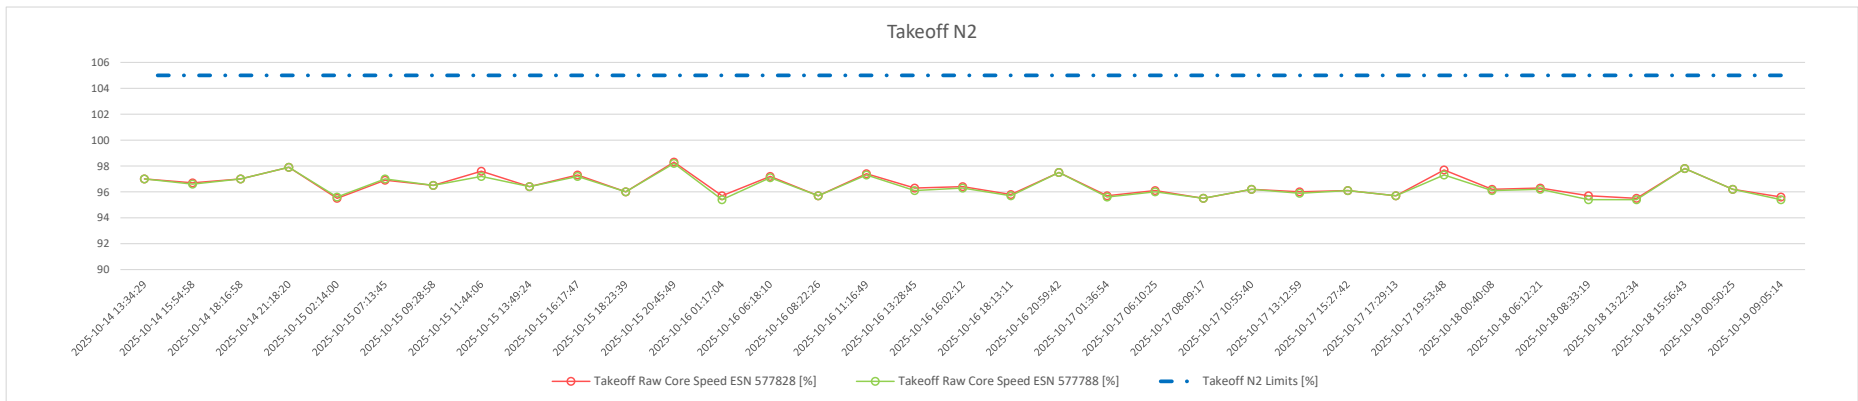
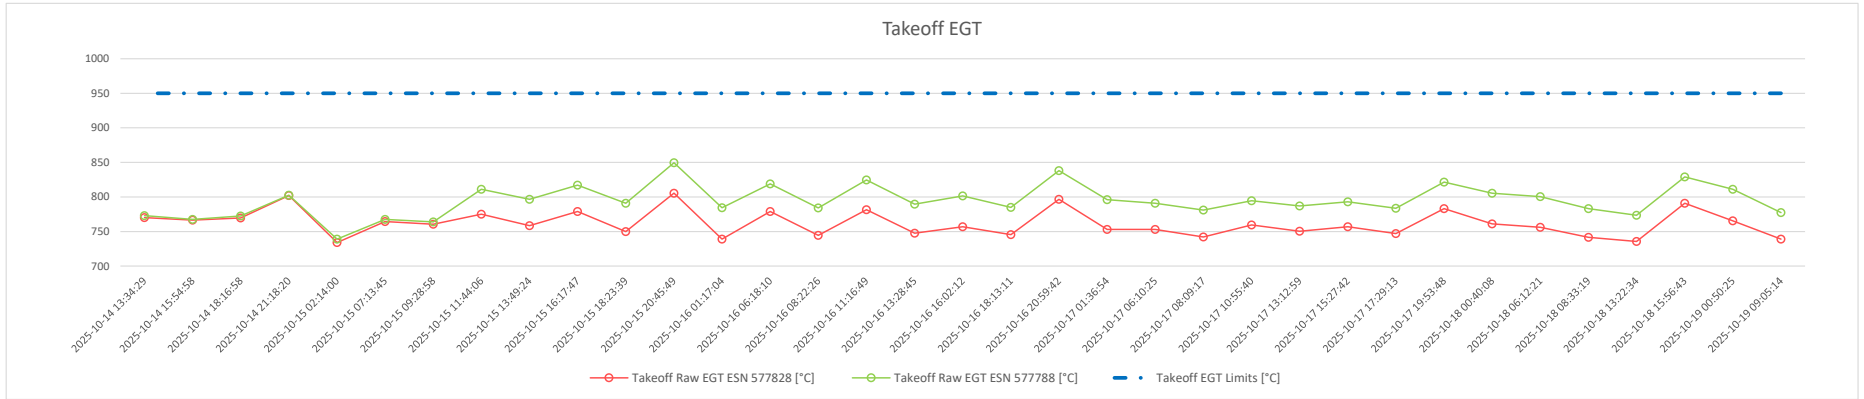
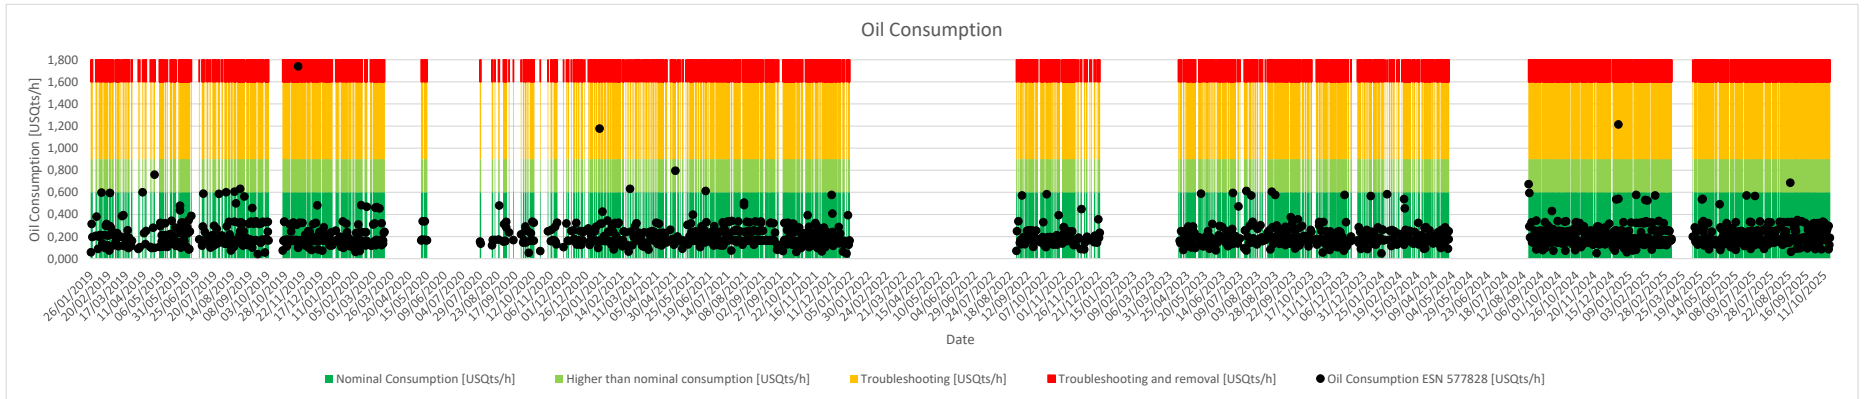
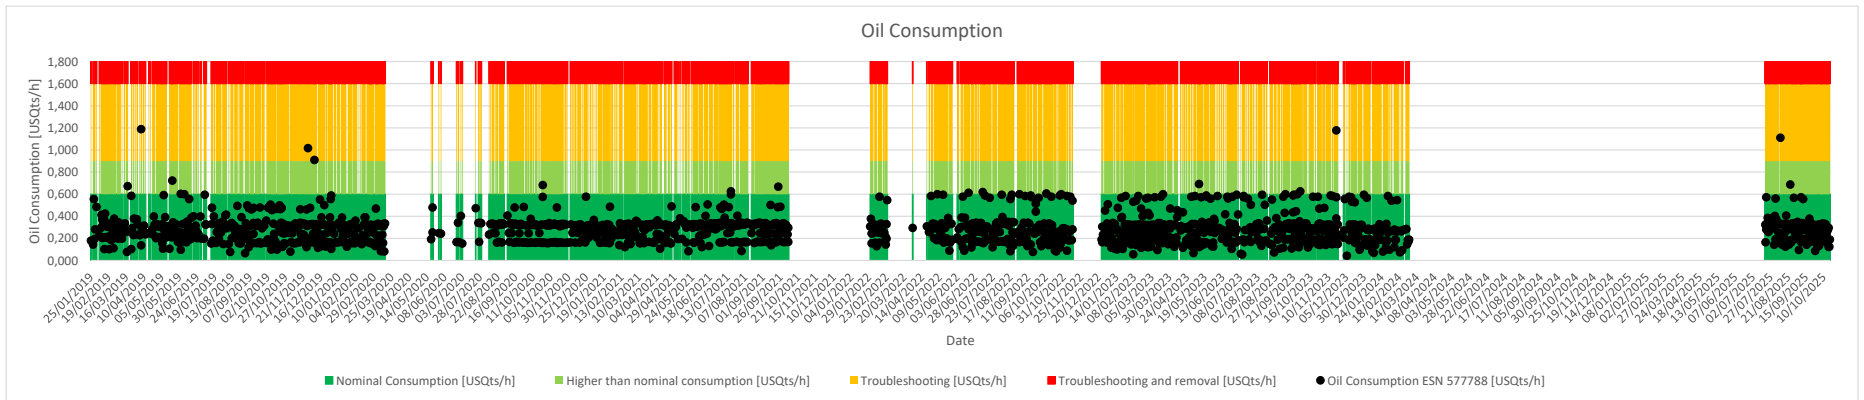
The engine in question experienced erratic shifts and/or lapses (Vibration = 0 Units) in fan/core vibrations at both cruise and takeoff as indicated by the **rear vibration sensor**. All other engine parameters are normal.

ESN 577788 (Pos.RH): (DEGT, DFF, DN2 up shifts; N1 Vibs up; EGT_m down)

2025_10_03: TFL 70741 dated 2025_09_30 : TSM Task 77-30-00-810-809, 810, 811, 812, 805, 806, 807, 808. Task 77-30-00-810-813-A performed, self-test OK was the result of the EVMU OPS Test. No maintenance message on PFR on any sensors mentioned in the TSM Task.
